A CASE HISTORY

Piers Save Credit Union

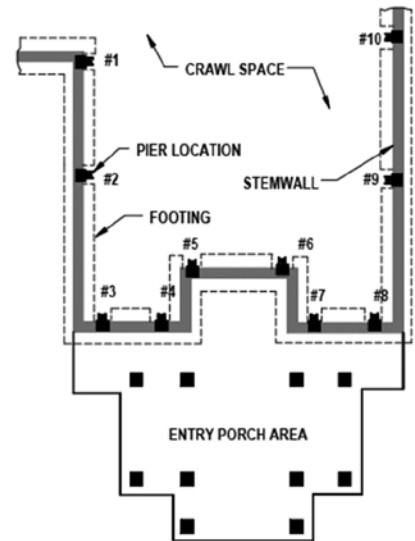
PIER LOCATION PLAN

The Atlas Resistance® Piers were driven to suitable bearing at 40 to 44 feet and tested during the application of the working loads. The sketch above shows the pier layout for support and restoration of the area near the covered entry porch.

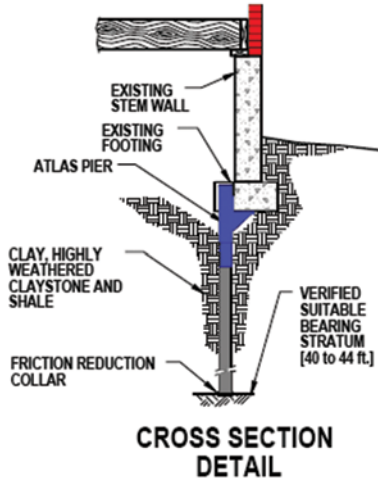
The sketch below shows a cross section detail of an Atlas Resistance® 2-Piece Pier as it was installed on this structure. You can see how the load has been transferred from the failing soil to a tested load bearing stratum some 40 feet below the surface.

On this project the 3-1/2-inch diameter pier pipe had a triple coat corrosion protection of zinc chromate and flow coat galvanize. The pier bracket and top pier platform were supplied mill finish steel. During installation all components of the pier system were carefully aligned to install the pier vertically. This insures proper load transfer of the structural weight to the pier assembly.

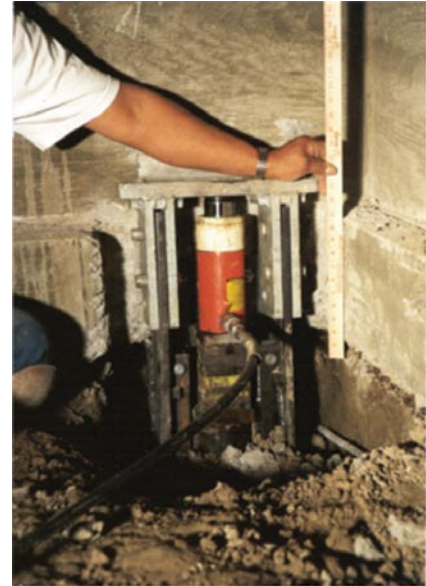
Above right is a photograph of pier No. 7 after recovering 1-1/2 inches of floor elevation. The photos below show a recovery of approximately 60 percent at a masonry tension fracture along the side of the structure near pier No. 10. The final step for this project was to improve the site drainage and to direct the downspouts away from the foundation.

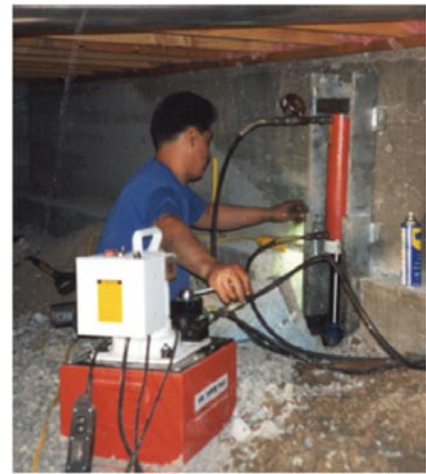
Notice how the footing was notched to allow the Atlas Resistance® Pier to be installed as close to the stem wall as possible.
