SUBSTATIONRebuild

Tight Times, Tight Spaces

An ambitious substation rebuild overcomes outage limitations and space constraints.

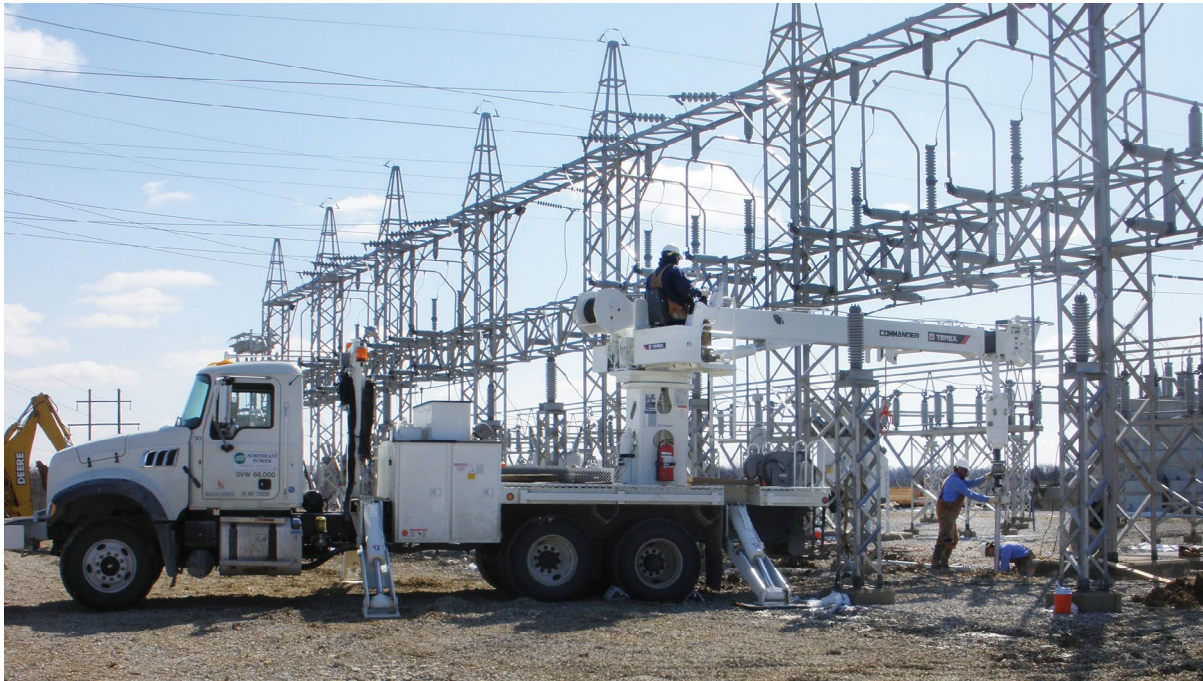
Workers drive in helical piles to augment a 69-kV tower foundation at Henry substation. Helical piles were the only way to go on this project. The work had to be completed in tight quarters, on a short deadline and while the substation was still energized.

CLC Engineering suggested the foundations could be augmented and helical piles could be used to support the new foundation sections. Helical piles can be drilled into the soil with a drive motor, and they are faster and easier to install than a traditional poured-concrete foundation. This seemed like a good solution. More importantly, it was the only viable solution, given the scope of work and time constraints.

However, Henry substation is not a big, spacious substation. Workers could not get drilling equipment into the south side of the 69-kV foundations because of energized bus work and underground duct work. The only option was to extend the foundations to the east, west and north.

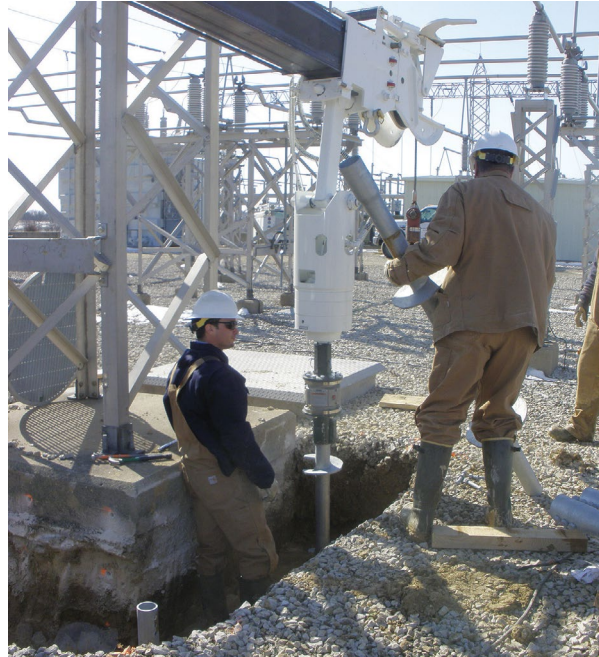
A work crew installs helical piles around three sides of an existing foundation.

Each horseshoe-shaped foundation addition is supported by four helical piles: two along the east side and two along the west side. Workers drove the piles in until 12,000 ft-lb (1600 m-kg) of torque was achieved. Then they cut off the top of each pile, 1 ft (0.3 m) below the future concrete surface and welded-on metal caps.

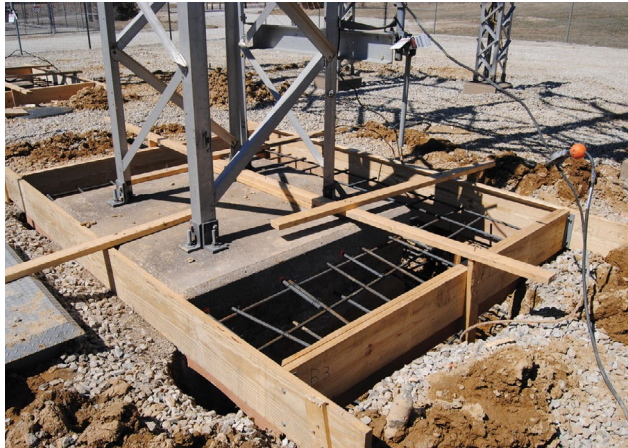
After the helical piles were cut and capped, workers added the rebar dowels and built the concrete form. This foundation is ready for the modified mix of concrete.

To transfer the shear forces from the new section to the existing foundation, Northeast Power designed a system of dowels. Workers bored 12 horizontal holes 12 inches (0.3 m) deep into each side of the existing foundations, for a total of 36 per foundation. Crews inserted 2-ft (0.6-m) sections of 7/8-inch (22.2-mm) rebar in each hole to tie the whole thing together. Workers noted that, from a top view, "The foundation looked like a big porcupine."

The concrete mixture was adjusted to speed up the curing process and ambient temperature was watched carefully. March is typically cool in Iowa and the temperature fell below freezing a few times. When this happened, Northeast Power used insulated blankets over the freshly poured foundations.

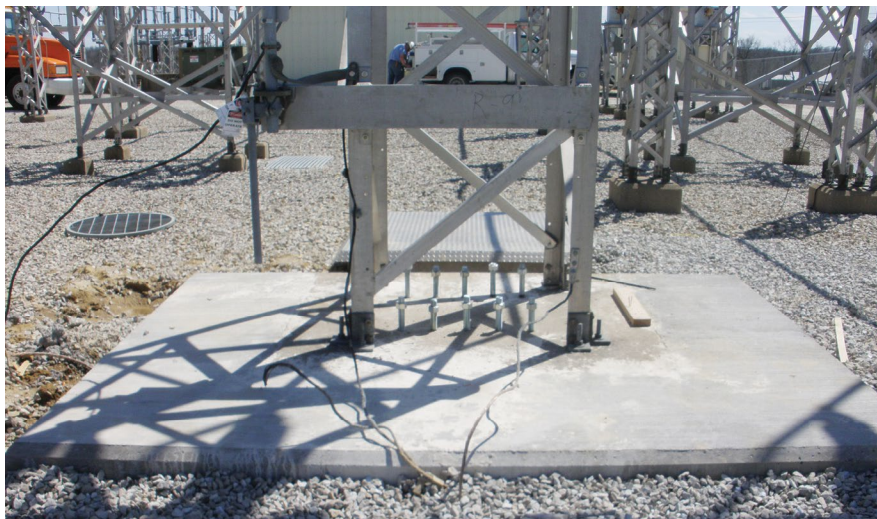
This smooth finished foundation covers all the work involved in the installation of helical piles that were used to extend the foundation from its original dimensions.

On the 69-kV side of the yard, the work was more challenging. The existing 6-ft by 6-ft (1.8-m by 1.8-m) concrete foundations were 7-ft (2.1-m) deep. To meet the new load and moment requirements, the foundations had to be expanded to 12 ft by 9 ft (3.7 m by 2.7 m). The main problem, of course, was clearances. The vertical restriction was 15 ft (4.6 m). Hubbell Power Systems specified helical piles with shorter-than-typical lead sections, and Northeast Power used 5-ft (1.5-m) extension rods. Even so, the coop had to be creative when it came to driv-
