**SUBSTATION**Rebuild

# Tight Times, Tight Spaces

An ambitious substation rebuild overcomes outage limitations and space constraints.

By **Jamie Page, Gary Wood** and **Kevin White**, *Northeast Missouri Electric Power Cooperative*

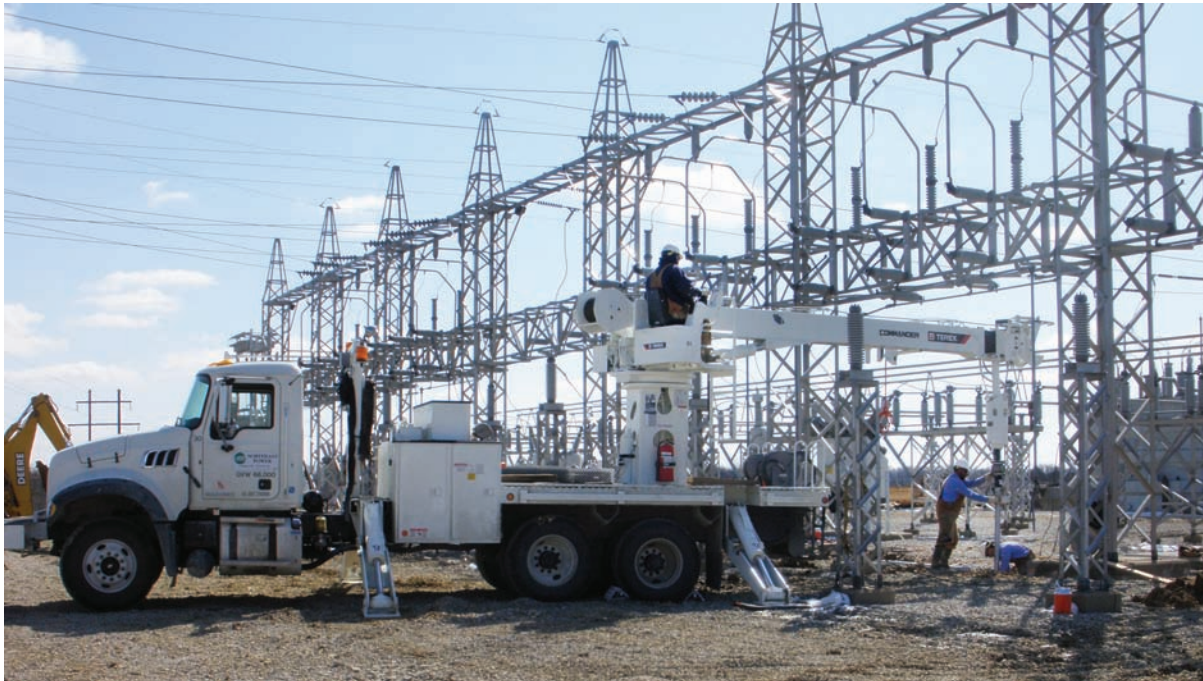
Workers drive in helical piles to augment a 69-kV tower foundation at Henry substation. Helical piles were the only way to go on this project. The work had to be completed in tight quarters, on a short deadline and while the substation was still energized.

CLC Engineering suggested the foundations could be augmented and helical piles could be used to support the new foundation sections. Helical piles can be drilled into the soil with a drive motor, and they are faster and easier to install than a traditional poured-concrete foundation. This seemed like a good solution. More importantly, it was the only viable solution, given the scope of work and time constraints.

However, Henry substation is not a big, spacious substation. Workers could not get drilling equipment into the south side of the 69-kV foundations because of energized bus work and underground duct work. The only option was to extend the foundations to the east, west and north.

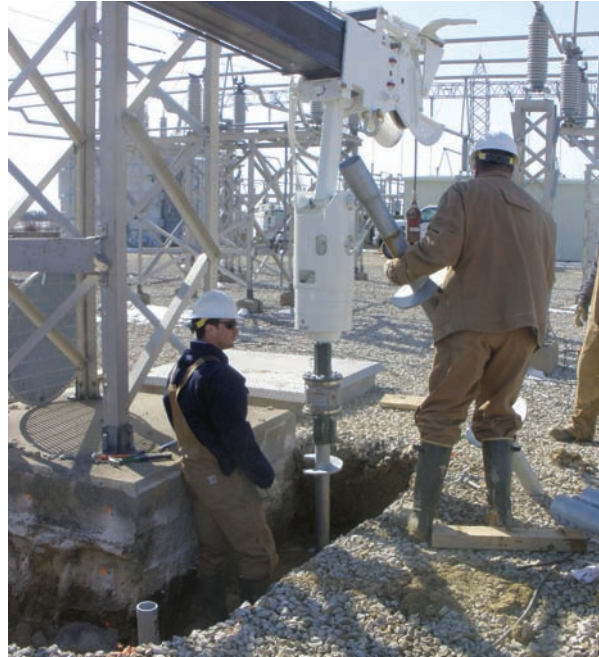
A work crew installs helical piles around three sides of an existing foundation.

On the 69-kV side of the yard, the work was more challenging. The existing 6-ft by 6-ft (1.8-m by 1.8-m) concrete foundations were 7-ft (2.1-m) deep. To meet the new load and moment requirements, the foundations had to be expanded to 12 ft by 9 ft (3.7 m by 2.7 m). The main problem, of course, was clearances. The vertical restriction was 15 ft (4.6 m). Hubbell Power Systems specified helical piles with shorter-than-typical lead sections, and Northeast Power used 5-ft (1.5-m) extension rods. Even so, the coop had to be creative when it came to driv-

A digger-derrick truck was brought in instead of a larger piece of equipment. Workers had to remove the Kelly bar from the auger and then attach the torque indicator and installation tool directly to the motor shaft. This helped with the clearance issues and gave workers a couple of feet to spare. Nevertheless, the coop had to de-energize and remove the 69-kV transfer bus to begin the foundation work.

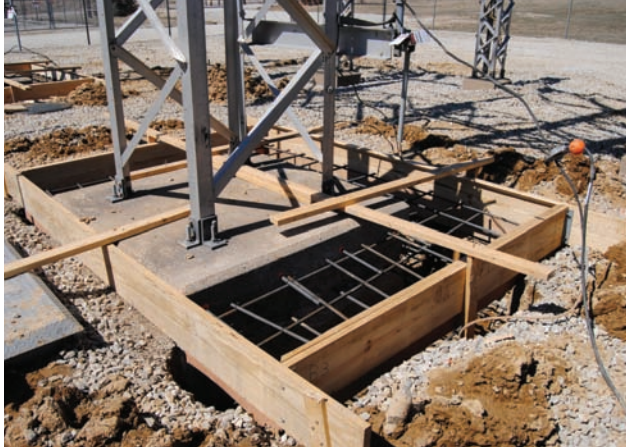
After the helical piles were cut and capped, workers added the rebar dowels and built the concrete form. This foundation is ready for the modified mix of concrete.

Each horseshoe-shaped foundation addition is supported by four helical piles: two along the east side and two along the west side. Workers drove the piles in until 12,000 ft-lb (1600 m-kg) of torque was achieved. Then they cut off the top of each pile, 1 ft (0.3 m) below the future concrete surface and welded-on metal caps.

To transfer the shear forces from the new section to the existing foundation, Northeast Power designed a system of dowels. Workers bored 12 horizontal holes 12 inches (0.3 m) deep into each side of the existing foundations, for a total of 36 per foundation. Crews inserted 2-ft (0.6-m) sections of 7/8-inch (22.2-mm) rebar in each hole to tie the whole thing together. Workers noted that, from a top view, "The foundation looked like a big porcupine."

The concrete mixture was adjusted to speed up the curing process and ambient temperature was watched carefully. March is typically cool in Iowa and the temperature fell below freezing a few times. When this happened, Northeast Power used insulated blankets over the freshly poured foundations.

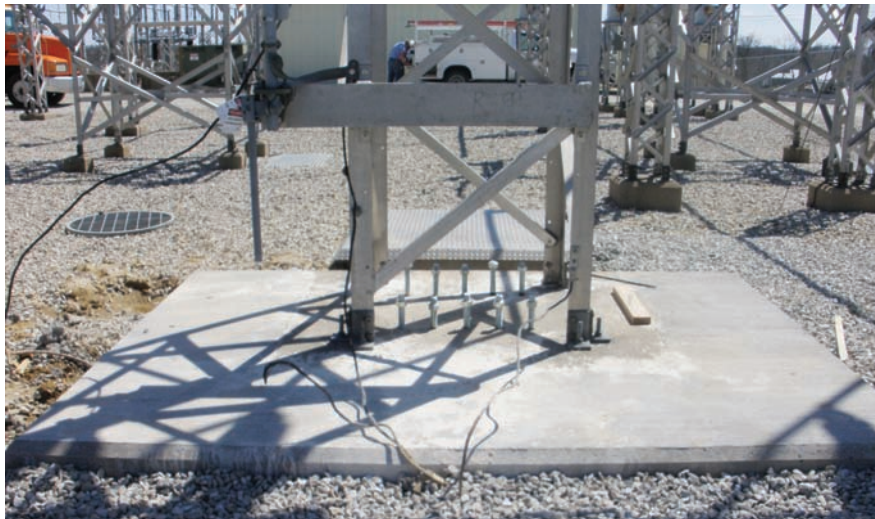
This smooth finished foundation covers all the work involved in the installation of helical piles that were used to extend the foundation from its original dimensions.
