How an SDC™ Bushing Test Tap is Constructed

Comments on Capacitance and Power Factor Measurements of the Tap Insulation on SDC Epoxy Bushings

Recommended SDC Test Tap Cleaning Procedure

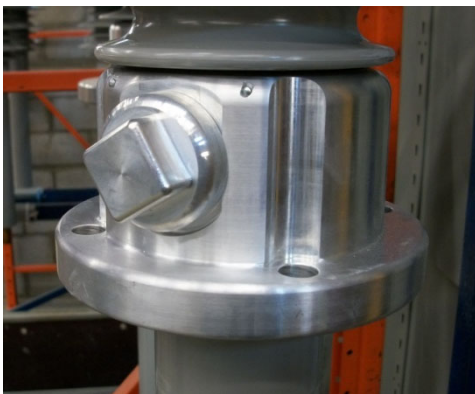
The test tap is comprised of a cover, spring, contact washer and sealing o-ring, and a connection pin threaded into the ground shield contact plate. When in place, the cover, spring, and contact washer are short-circuited to the ground shield contact plate to insure proper grounding during normal bushing operation. The bushing test tap must be screwed into the flange during normal operation of the bushing. Failure to fully screw the test tap in place when the bushing is in service will result in failure of the bushing.

Schematic View of a Typical SDC Test Tap

The tap cover, contact spring and washer are used to make electrical contact between the ground shield and flange. The spring and washer are press-fit into the cover and should not be disassembled. When the cover is screwed into the flange, the spring is compressed and insures proper contact with the ground shield contact plate. The tap pin is screwed into the ground shield contact plate and is only used to facilitate measurement of the bushing capacitance and power factor values. The cover o-ring seals the tap from moisture/water ingress.

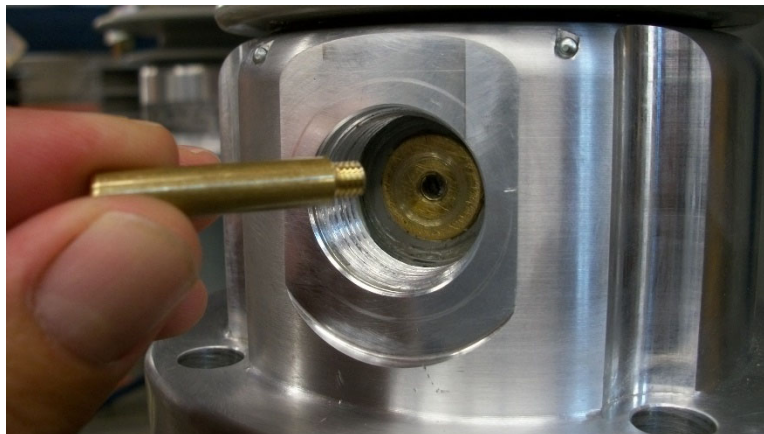
- Unscrew the test tap pin using a flat-head screwdriver.

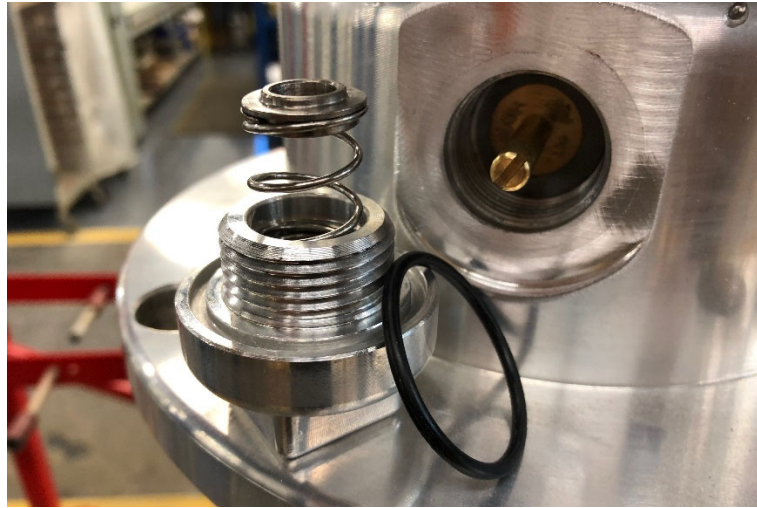
- To perform the bushing C_2 test, hook up the HV test lead to the tap pin, preferably using a lower weight wire equipped with alligator type jaws to prevent damaging the tap pin, and connect the LV test lead to the flange.
- Once the bushing has been tested, check the test tap cover o-ring for signs of aging (cracking, splitting, lack of elasticity) and replace as needed. Also check the flat face surface of the flange around the test tap for scratches or oxidation buildup and clean as needed. A small amount of petroleum jelly may be used to lubricate the o-ring when placing it into the tap cover. Do not fill the test tap with anything (leave dry).

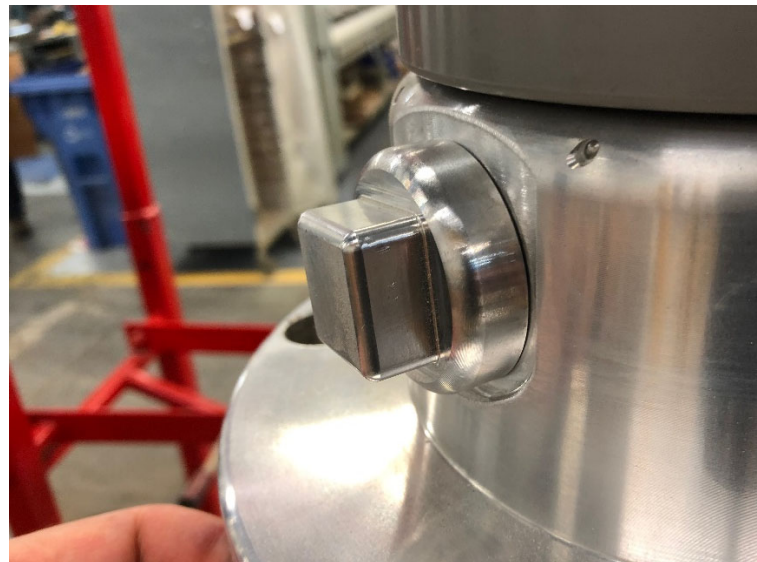
- Thread the tap cover assembly clockwise ensuring that the spring and contact washer are securely in place inside the tap cover.
- Tighten the tap cover until it makes contact with the flange surface (metal to metal). Do not tighten the tap cover any further.
