CASE HISTORY

# **STORMS CAUSE CHAOS**

XCEL ENERGY COPES WITH A SUMMER STORM THAT DAMAGED MORE THAN 100 STRUCTURES.

BY MATTHEW HOESE, XCEL ENERGY

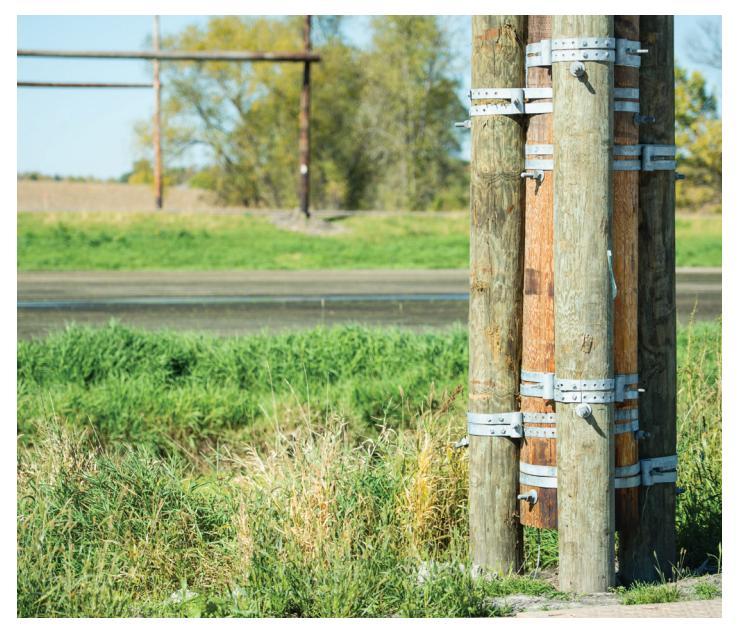
Xcel Energy had enough wood poles on hand to rebuild the first line, which was installed on driven wood pilings.

As there were enough wood poles on hand to rebuild the Monticello line, Xcel Energy decided to go forward with wood replacement. Because the Sherco line rebuild could wait, the engineering department had time to ex-plore other options for its replacement.

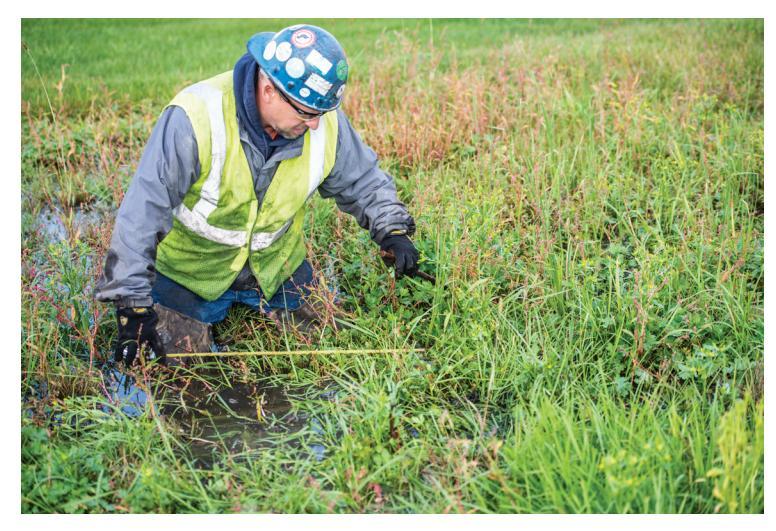
The engineering team determined where the tower would go, but the farmland and marsh terrain made the rebuild a challenge.

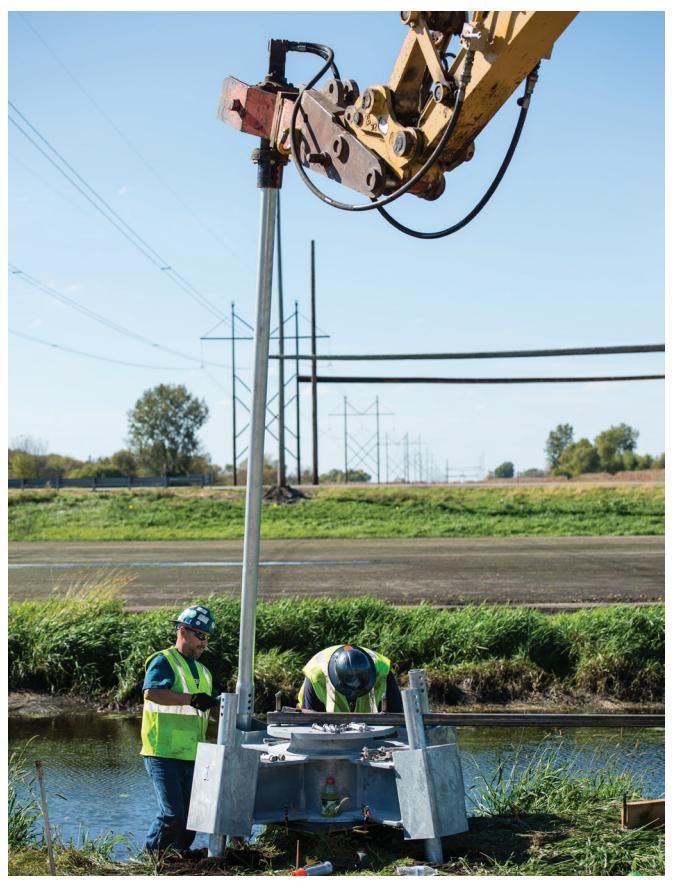
Helical piling supports the second steel pole line. These piles are installed with a drive head attached to a small digger and work well in poor load bearing soil, even marshland.

The second problem to address was the piles. Driving wood poles into wet, peaty soil takes time and big equipment, which has a significant impact on the surrounding environment. Helical piles can be screwed into the ground quickly with a special drill head on a small backhoe, minimizing environmental impact.

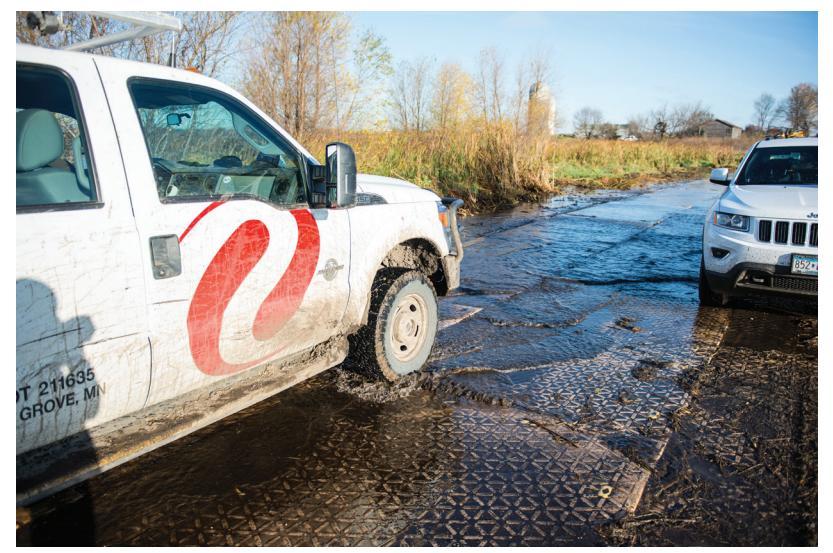
Matting was necessary to get vehicles and workers to almost all tower foundation sites.

Matting also was a significant issue. To prevent damage to the land and keep vehicles from getting stuck in the mud, matting was required any time a vehicle had to cross wet ground or farmland. Since most of the right-of-way is boggy, there are many drainage ditches and drain tiles under the ground. (Farmers use drain tiles to direct ground water from their fields.) Also muddying the waters was the fact that 2016 was an extremely wet season, which raised the water table to almost ground level. This resulted in contractors matting into most, if not all, of the structures.

Putting mats down is expensive, but helical piles can be installed with much smaller equipment and that translates into significantly less matting. This lowers costs and reduces field impact, which is especially important on agricultural land. As it was, crews used

nearly 7800 polymer mats to ensure safe access to the structure sites.

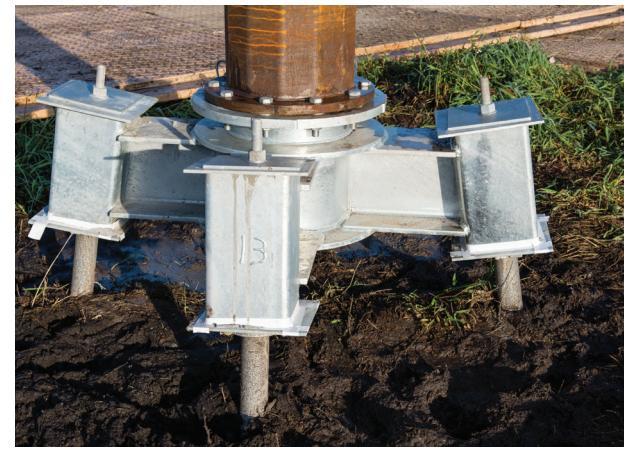
After the four permanent helical piles were drilled in, workers installed a grillage on top and grouted it in place. Then they installed a top cap and mounted the steel towers

Engineering the design was a collaborative effort. Jeff Gutzmann worked with HPS on the helical pile design. The final design called for four piles per foundation, each with five helicals — one at 10 inches, one at 12 inches and three at 14 inches (254 mm, 305 mm and 356 mm, respectively). Depths varied from pile to pile and location to location but were typically between 25 ft to 35 ft (7.6 m to 10.7 m). Xcel Energy's construction department selected a contractor with prior experience working with CHANCE helical foundations, and the contractor purchased and installed the specified piles from HPS.

Once the piles were driven into the ground, a grillage was attached to the top and grouted into place. The grillage is like a cap. It is welded together, and there are holes for the tops of the helicals. These are filled with grout to hold down the grill and a baseplate. The grouted pockets were used to create a moment connection between the piles and the grillage. HPS designed the grillage and an Xcel Energy engineer inspected the material as it arrived, checked the welding and oversaw the installation.
