UNDERPINNING ANCHORING REPORT

A CASE HISTORY

One-story brick house, Richmond, Virginia

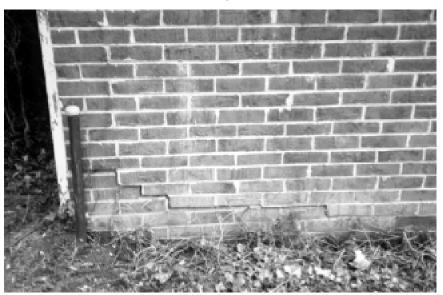
BEFORE

A 17-year-old house had settled approximately $^{7}/_{8}$ inch at a front corner. This settlement resulted in a $^{5}/_{8}$ inch horizontal crack along a 4-ft. section of the front and a 3-ft. section of the side.

A 2x3-ft. hole was dug at three pier locations. Two 10-inch diameter Helical Pier® Foundation Systems screw anchors were installed on the front and one on the side. Each anchor was installed to an 18-ft. depth with 2,500 ft.-lb. of torque for a load capacity of 25,000 lb. A foundation bracket was connected to each anchor and the footer.

The three anchors were loaded gradually to 14,000 lb. by simultaneously using three 10-ton Enerpac hydraulic jacks. This closed the $^{5}/_{8}$ inch crack to only $^{1}/_{16}$ inch and new mortar was installed.
